# MFLi3000

Motorised MFL Floor Scanner with Real Time Scan, MFLi and STARS Top Surface View

## ADVANCED MFL TANK INSPECTION WITH REAL TIME SCAN, STARS TOP VIEW & MFLi DEFECT ANALYSIS

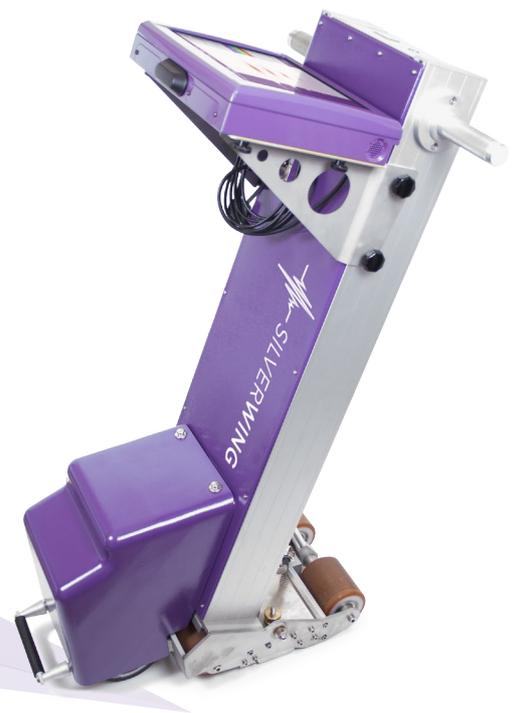
The MFLi3000 is designed to increase productivity by providing the technician with powerful yet simple analysis tools.

The flexible system adapts to the testing procedures being used, whether it be monitoring a real time display, automatically stopping on defect or reviewing a whole scan at the end of a run.

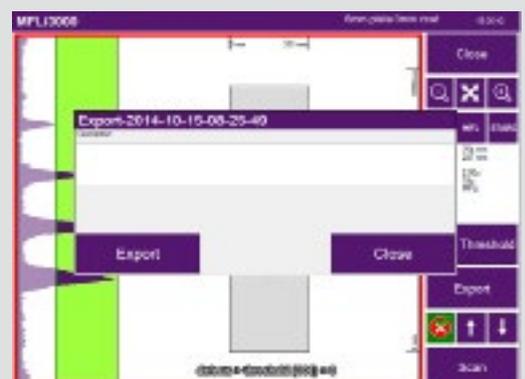
The MFLi3000 does not have full data recording and mapping, but still allows the technician to save particular scans of interest with addition notes.

These scans are stored in standard PNG image format that can be viewed with many word processing and image software applications or imported in to the CMAP reporting software. This gives an added level of confidence to reports, showing corrosion patterns in addition to the normal thickness record given by manual prove up.

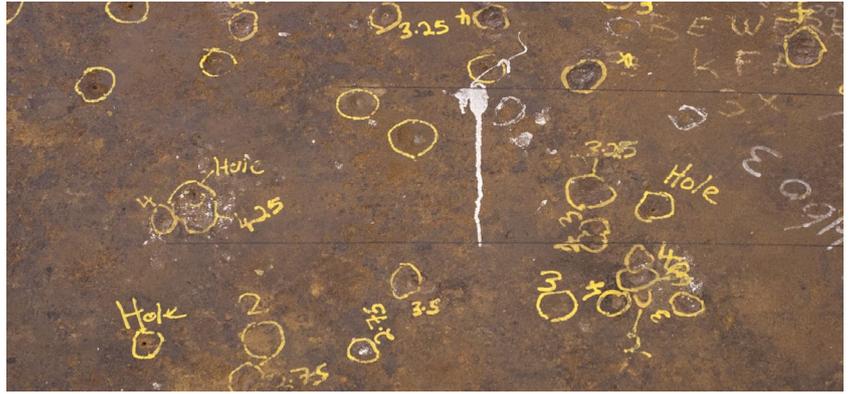
### CORRODED PLATE SAMPLE

Extensive top side corrosion pitting.
